# Archeology at Mount Comfort Church: An Antebellum Meeting House in Northwest Arkansas

Jerry E. Hilliard (Arkansas Archeological Survey)

## Excavating an Antebellum Public Building in the Arkansas Ozarks

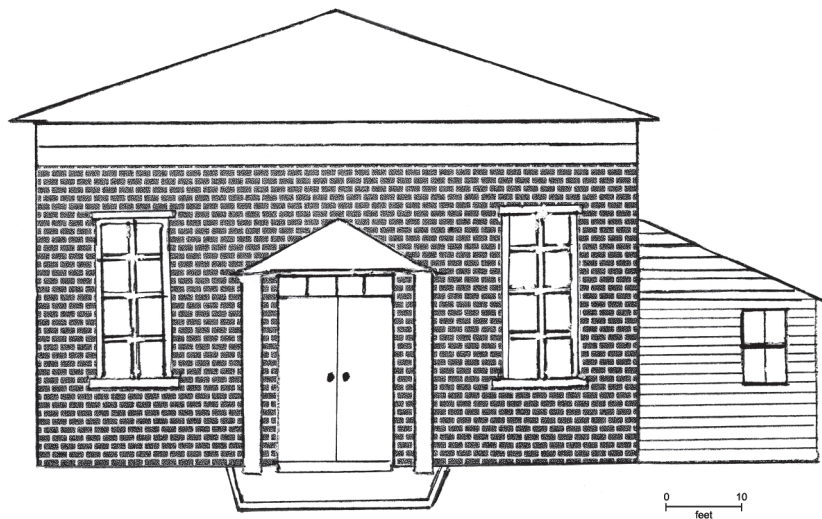
Reconstruction of the Second Mount Comfort Church, ca. 1848, based on archeological evidence.

Architectural details gleaned from over 6000 artifacts indicate the brick structure was indeed, as noted in Ann Marshall’s autobiography, about 33 feet square. The front of the building faced east with central doors that opened onto a small wooden porch. There were two to three windows on each side of the building, with dressed sandstone lintels. A lack of nails suitable for wainscoting in excavation units within the church indicate the interior walls were left as bare brick. Evidence of a 27 x 10 foot wood-frame addition was found on the north side of the brick structure, consisting of foundation stones, wall plaster, pane glass, ash, flooring nails, and one charred floor joist. One heavy iron door hinge discovered between the brick wall and the wood addition indicates a large door connected the interior of the brick church to the addition. Slate tablet fragments, lead pencil nubs, marbles, and an iron bell clacker attest the use of the wood addition as a schoolroom. We feel certain this was the “music room” added in 1848 for the Mount Comfort Female Seminary, as noted in Ann Marshall’s autobiography.

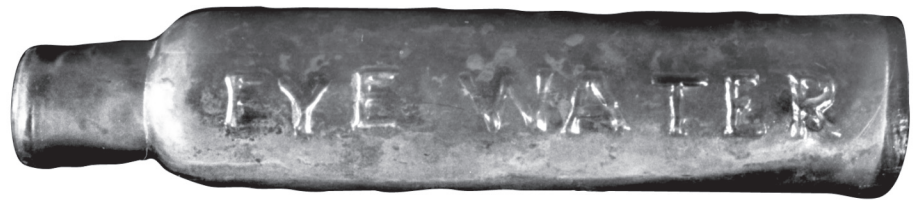
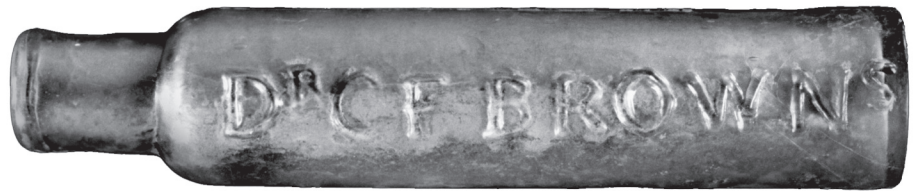
Embossed medicine bottle: “C.F. Brown’s Eye Water.”

in the Van Buren area before the war and later served as a Confederate surgeon. In 1859 his practice was near a sulphur spring outside of Van Buren, and the spring water was used for medicinal purposes. “Dr. C. F. Brown’s Eye Water” was likely marketed and sold in specially produced embossed bottles like the one we found at Mount Comfort. In a January 1862 issue of *The War Bulletin* Dr. Brown reported the deaths of 12 men since the organization of the Mount Comfort hospital. The trouble was, we were not certain exactly where Mount Comfort hospital was.

There were several public buildings in the Mount Comfort area during the war. The references in the written documents were not enough to determine which one had been pressed into use as the hospital. The discovery of the embossed bottle, along with other Civil War artifacts, at the Mount Comfort Church site confirm that this was the place.
