Archeology at Mount Comfort Church: An Antebellum Meeting House in Northwest Arkansas

Jerry E. Hilliard (Arkansas Archeological Survey)

Excavating an Antebellum Public Building in the Arkansas Ozarks

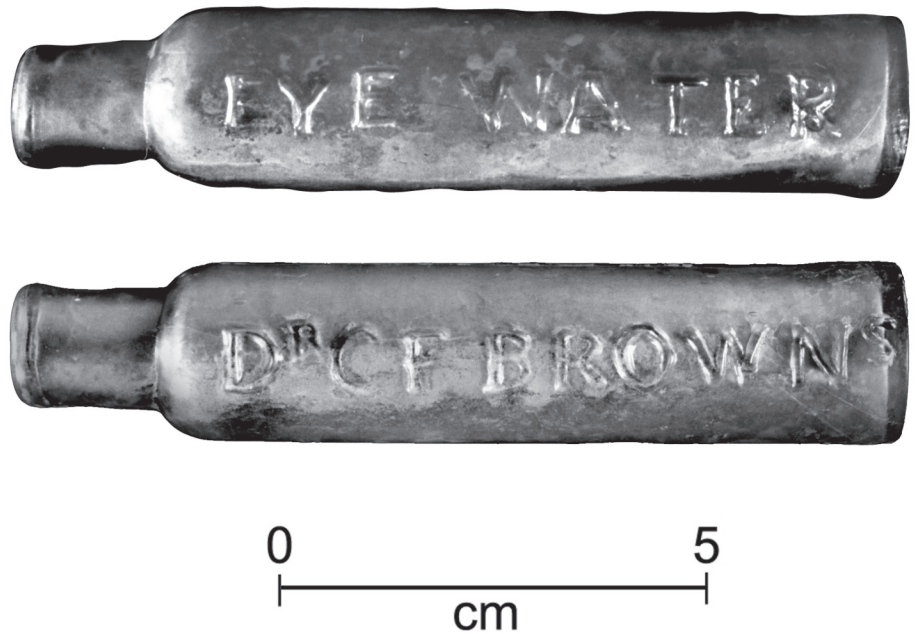
Embossed medicine bottle: “C.F. Brown’s Eye Water.”

in the Van Buren area before the war and later served as a Confederate surgeon. In 1859 his practice was near a sulphur spring outside of Van Buren, and the spring water was used for medicinal purposes. “Dr. C. F. Brown’s Eye Water” was likely marketed and sold in specially produced embossed bottles like the one we found at Mount Comfort. In a January 1862 issue of *The War Bulletin* Dr. Brown reported the deaths of 12 men since the organization of the Mount Comfort hospital. The trouble was, we were not certain exactly where Mount Comfort hospital was.

There were several public buildings in the Mount Comfort area during the war. The references in the written documents were not enough to determine which one had been pressed into use as the hospital. The discovery of the embossed bottle, along with other Civil War artifacts, at the Mount Comfort Church site confirm that this was the place.
